SHOULDER RUMBLE STRIPS:

A METHOD TO ALERT "DRIFTING" DRIVERS

Neal E. Wood, P.E.
Bridge Engineer (Retired)

January 1994

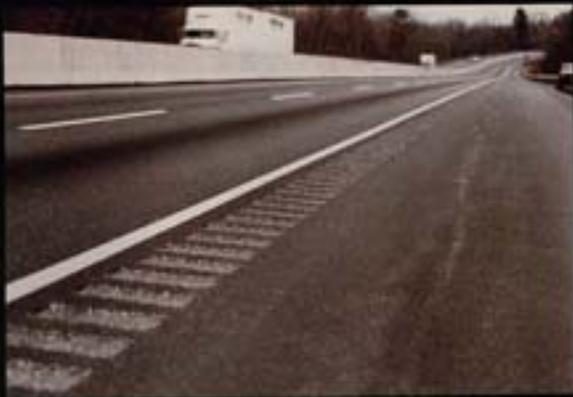
1

Sonic Nap Alert Pattern (SNAP) A Method to Alert "Drifting" Drivers

This paper presents the Pennsylvania Turnpike's development of a new safety feature, the Sonic Nap Alert Pattern, appropriately abbreviated as "SNAP." The Pennsylvania Turnpike's SNAP is a narrow, continuous rumble strip located in the right shoulder, just outside of the edge line of the pavement as shown on our Title Slide ([Slide 1](#)). The actual geometrics of the SNAP will be discussed later.

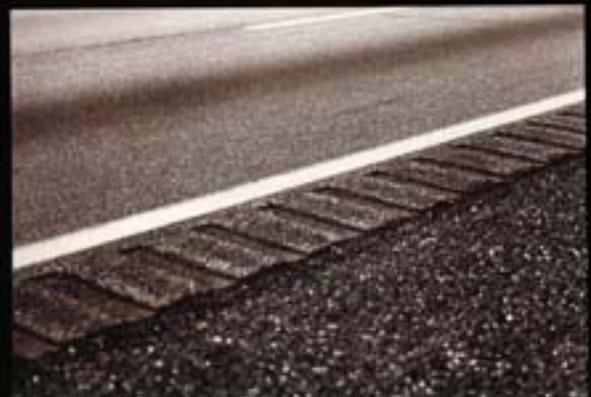
6

Sonic Nap Alert Pattern (SNAP)

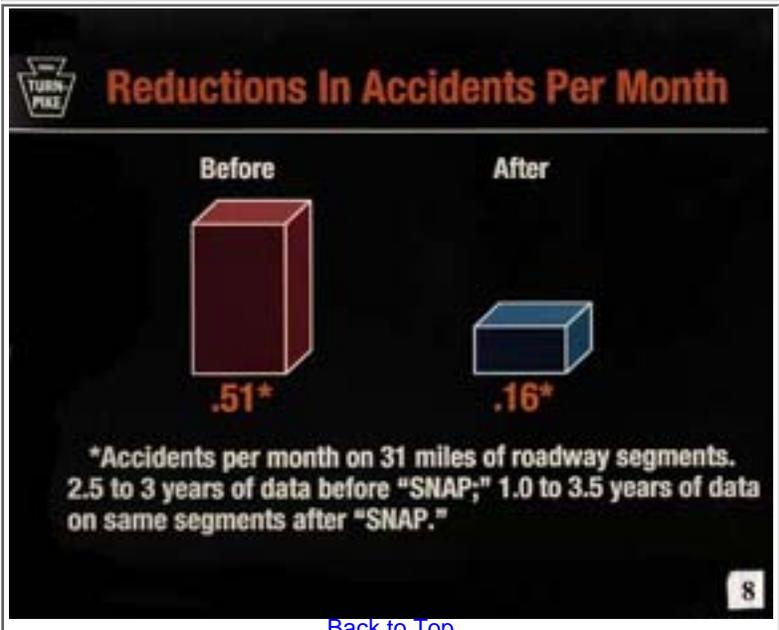
*Accidents per month on 31 miles of roadway segments. 2.5 to 3 years of data before "SNAP;" 1.0 to 3.5 years of data on same segments after "SNAP."

number of months studied, the data was reduced to "Accidents per Month" (A/M). Results are shown in [Slide 8](#). As indicated in the footnote on the slide, at least a continuous year of data is included on each roadway segment, both before and after installation of SNAP, so seasonal effects should be minimal.
