DEFINITY®

Enterprise Communications Server

Release 6

Maintenance for R6vs/si

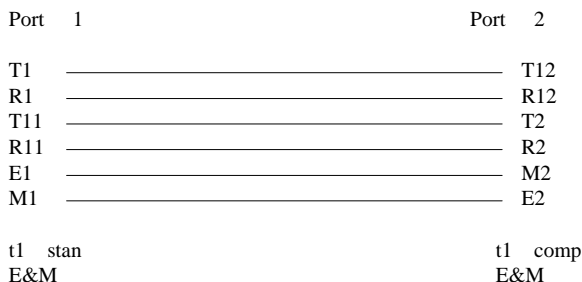
10. Locate the Tie Trunk port terminal connections at the cross-connect field. See [Table 5-4](#).
11. At the cross-connect field, disconnect outside trunk facilities from the Tie Trunk ports and mark the disconnected wires for later reconnecting the Tie Trunk ports back to normal operation. The D Impact Tool (AT-8762) is required to perform this step.
12. Use jumper wires (DT 24M-Y/BL/R/G and DT 24P-W/BRN) and the D Impact Tool to connect wiring between the two ports assigned in Step 9 at the cross-connect field. For example, if the two ports on the Analog Tie Trunk circuit pack are port 1 and 2, connect the wirings as shown below:

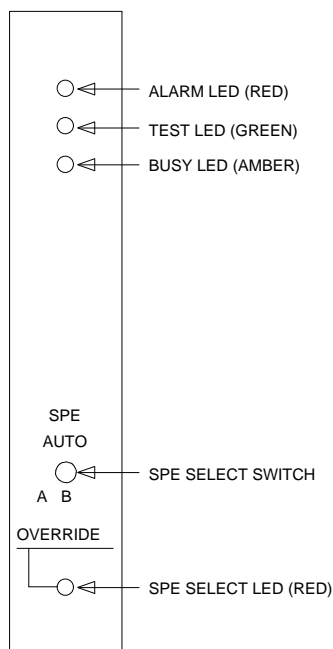
Figure 7-2. Duplication Interface Circuit Pack Indicators

In a High or Critical Reliability system, there are two Duplication Interface circuit packs. One is located in carrier A and one in carrier B of the PPN. Each circuit pack has two groups of LEDs. The top three have the traditional function of indicating the status of the pack. The LED located at the bottom of the faceplate directly beneath the SPE AUTO switch is labeled **OVERVERRIDE**. Under normal operating conditions, the SPE AUTO switch is in the **AUTO** (center) position (see [Figure 7-2](#)). This means that the system controls which SPE is active. However, there will be times (during maintenance activity, for example) when you, the technician, may choose to manually override the SPE selection function. To override system selection of the Active processor, move the SPE Select switches one at a time on *both* Duplication Interface circuit packs from the **AUTO** position

To return control of the SPE selection to the system, return the SPE Select switches on both Duplication Interface circuit packs to the AUTO position (one at a time to avoid accidentally selecting the other SPE). The OVERRIDE LED goes dark.

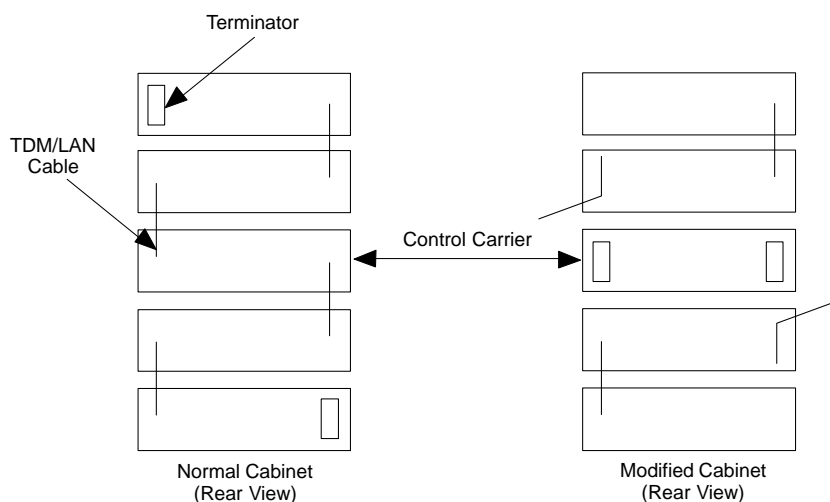
**Figure 9-7. Carrier Rewiring Example**

Circuit packs in carriers that are not part of the shortened bus are not inserted. As a result, these circuit packs are not alarmed. Ignore these alarms for now. All alarms should be resolved when the cabinet is restored to its original configuration.

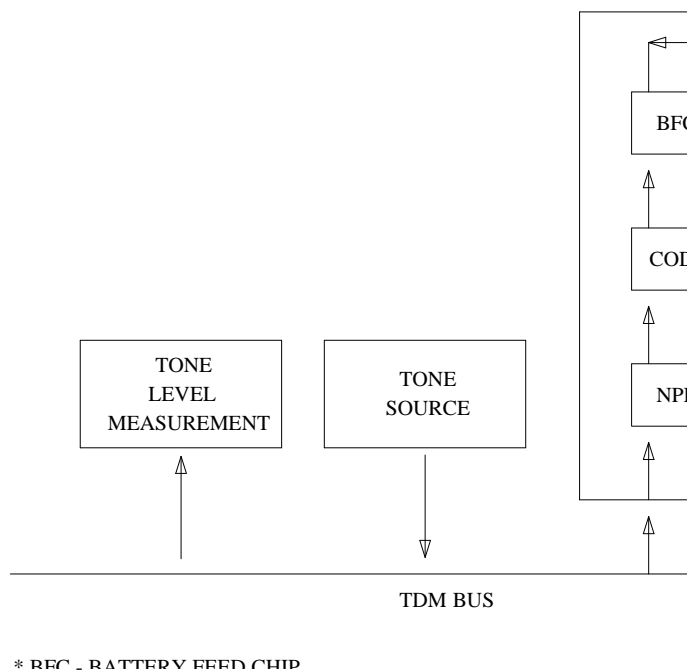
Figure 10-2. Analog Loop Around Test

This test is designed to check the on-board transmission capabilities of the NPE, the codec, and the battery feed chip of the analog port. A Tone Detector and a Tone Generator talk and listen on the same pair of time slots as the Analog Port. The Analog Port is then instructed to go into loop around mode (see the following below). The test passes if the signal measured by the Tone Detector is within acceptable limits.

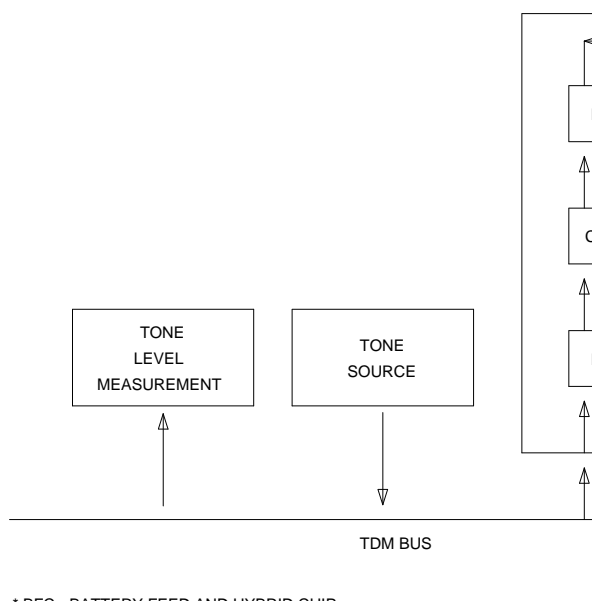
Figure 10-3. Analog Loop Around and Conference Test

This Loop Around Test is sensitive to the length of the loop, the equipment in the loop, or the equipment terminating the loop, such as off-premises stations. If this test is causing a false alarm, then disable the test by changing the Tests field to "no" using the **change station** command for this station.

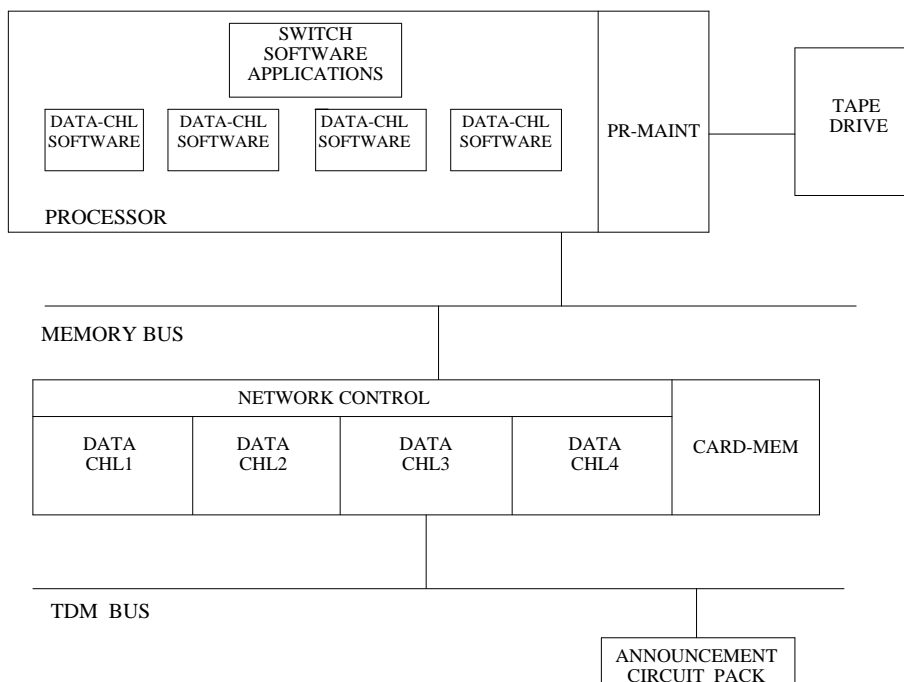
Figure 10-4. Connection of Announcement Circuit Pack to the System

Figure 10-4 shows the connection of the Announcement Circuit Pack to the system. To save or restore announcements, an ANNOUNCEMENT Data Extension must be administered, and at least one DATA-CHL (Network Control Data Channel) must be in the in-service/idle state.

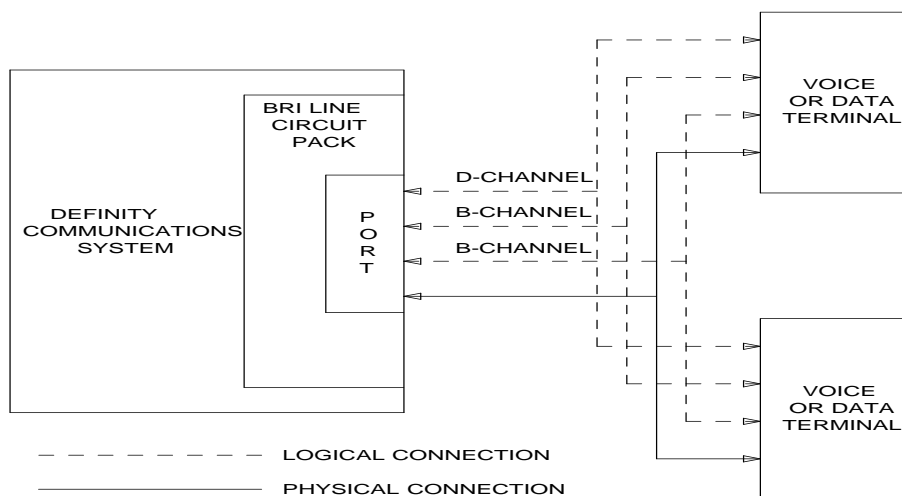
Figure 10-6 illustrates the physical connection (solid line) between an ISDN-BRI Port and its associated ISDN-BRI set(s). Each physical connection allows for two B-channels and one D-channel. Each ISDN-BRI circuit pack can support up to 12 of these *physical* connections to different voice and voice/data sets or ASAI or AT&T adjuncts. On a TN2198 each ISDN-BRI circuit pack can support up to 12 *physical* connections to a NT1, which, in turn, connects to 2 terminals.

Figure 10-6. ISDN-BRI Port Interactions

This section covers the maintenance documentation for ISDN-BRI ports. Some of the results of maintenance testing of ISDN-BRI ports may be affected by the health of the ISDN-BRI Line circuit pack (BRI-BD), BRI endpoint (BRI-SET), or ASAI adjunct (ASAI-AJ/LGATE-AJ) or AT&T adjunct (ATT_AJ/ATTE-AJ). These interactions should be kept in mind when investigating the cause of ISDN-BRI port problems. For more information on the circuit pack and endpoints, refer to the BRI-BD (ISDN-BRI Line Circuit Pack) Maintenance documentation, the BRI-SET (ISDN-BRI Endpoint) Maintenance documentation, and ASAI-AJ (Adjunct-Switch Application Interface) Maintenance documentation, ATT-AJ (AT&T Adjunct) Maintenance documentation, LGATE-AJ (Ethernet Adjunct-Switch Application Interface) Maintenance documentation, and ATTE-AJ (Ethernet AT&T Adjunct) Maintenance documentation.

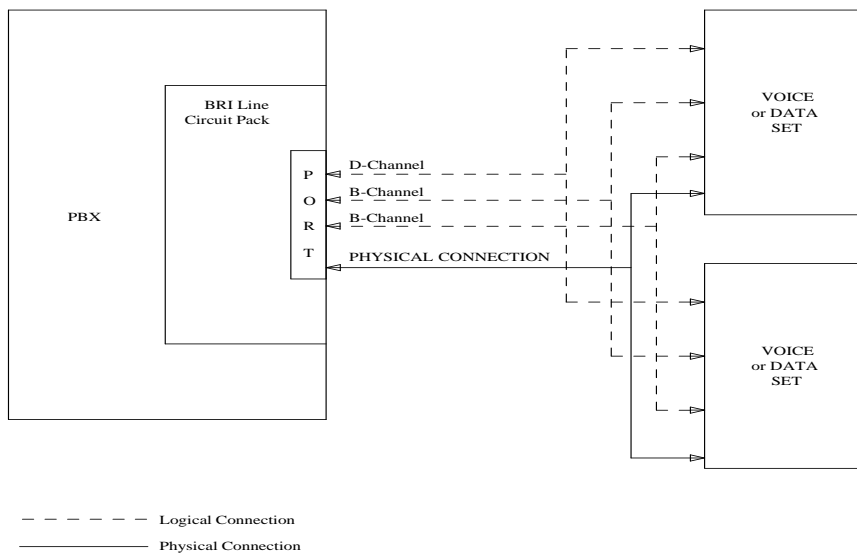
Figure 10-9 illustrates the physical connection (solid line) between an ISDN-BRI Circuit Pack and a voice or voice/data set. Each physical connection allows for two B-channels, as stated above, plus one D-channel. Each ISDN-BRI circuit pack can support up to 12 of these PHYSICAL connections to different voice and voice/data sets or ASAI and AT&T adjuncts.

Figure 10-9. ISDN-BRI Set Interactions

ISDN-BRI endpoints come in a number of configurations. All endpoints require the D-channel to convey signaling information to the switch. A voice-only set requires only one B-channel. A voice and data-capable set requires both B-channels (one for voice and one for data). Therefore, each TN556 port can support either two voice-only sets or one voice and data-capable set. Only a single ASAI or AT&T adjunct may be connected to an ISDN-BRI port. Multiple adjuncts per line are not supported.

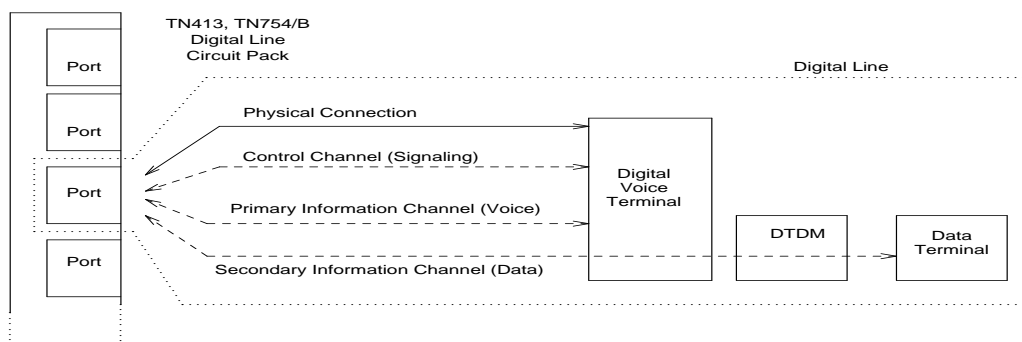
the primary information channel. Figure 10-26 shows examples of digital line connectivity.

Figure 10-26. Digital Line Connectivity

It should be noted that TN2181 and TN2224 supports both modes as shown in Figure 10-26 and Figure 10-27.

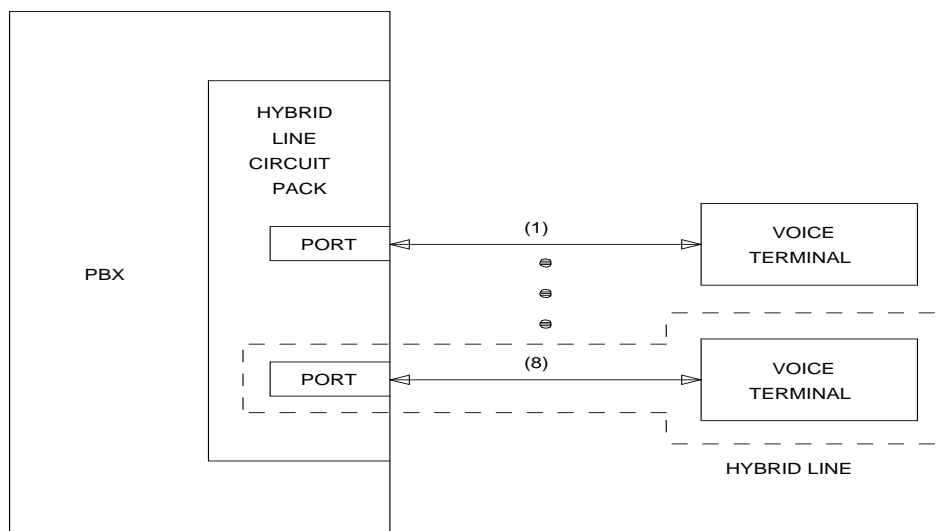
The TN762B Hybrid Line circuit pack supports eight of these multifunction analog telephone sets, as shown in the following figure. The Hybrid Line sets use three pairs of wires: an analog voice pair, a transmit/receive pair, and a power pair.

Figure 10-34. Hybrid Station Interactions

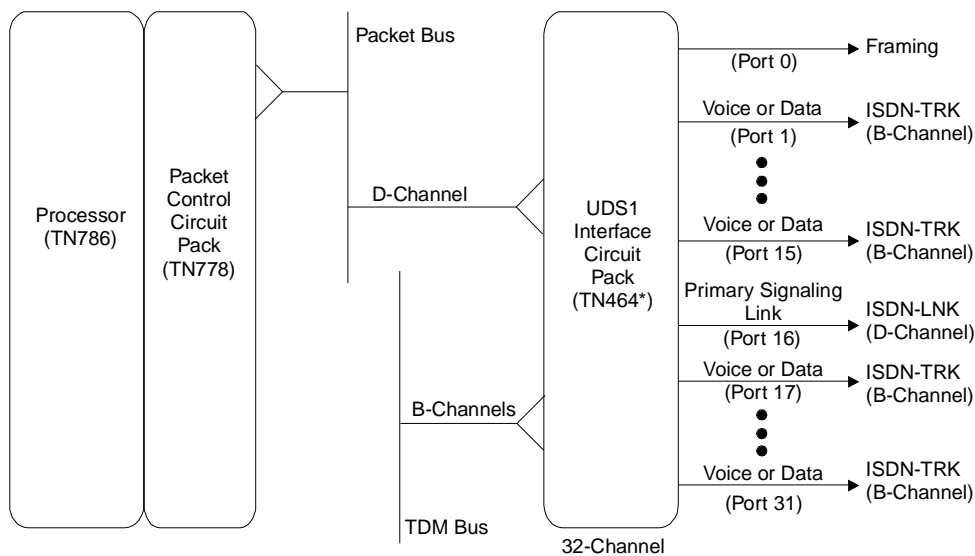
Figure 10-37. ISDN-PRI Signaling Link Port Interactions (32-Channel)

ISDN-PLK handles maintenance and recovery for the D-channel port on the DS1 carrying the signaling link. A problem with the ISDN-PRI Signaling Link Port (D-channel) has an effect on all of the associated DS1 ISDN Trunks or PRI endpoint ports (B-channels) since no call control information can be conveyed to the far-end switch or Terminal Adapter without it. Stable calls may remain operational, but no new calls can be made.

The ISDN-PRI Signaling Link Port (ISDN-PLK) itself depends on two other entities: the UDS1 interface circuit pack (TN464) it resides on, and the Packet bus which provides the link to the processor. If there are problems with the ISDN-PLK, also investigate the TN464 UDS1 interface circuit pack (UDS1-BD) and the packet bus (PKT-BUS).

*TN464 C or later

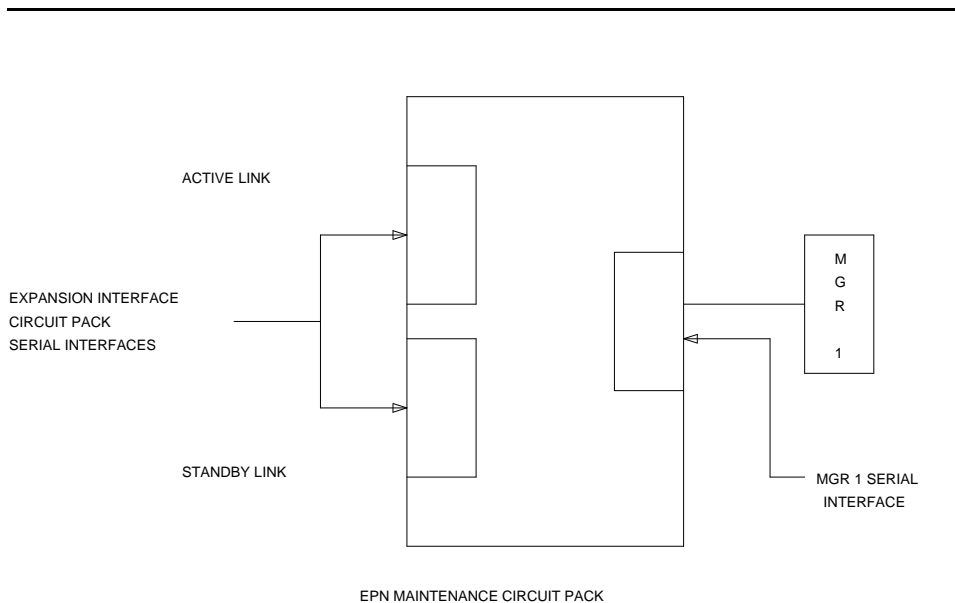
Figure 10-64. EPN Expansion Links Connections

This test checks the on-board circuitry of the EPN Maintenance circuit pack associated with the serial links to the Expansion Interface circuit pack. [Figure 10-64](#) shows the three serial interfaces on the EPN Maintenance circuit pack and is meant to clarify that the two dealing with the Expansion Links are being tested. A request is sent to the EPN Maintenance circuit pack over the Active link via the Active Expansion Interface circuit pack serial interface circuitry to test the serial interface circuitry of the standby Expansion Interface circuit pack link. If a response is received, then by definition the serial interface circuitry associated with the Active link is good.

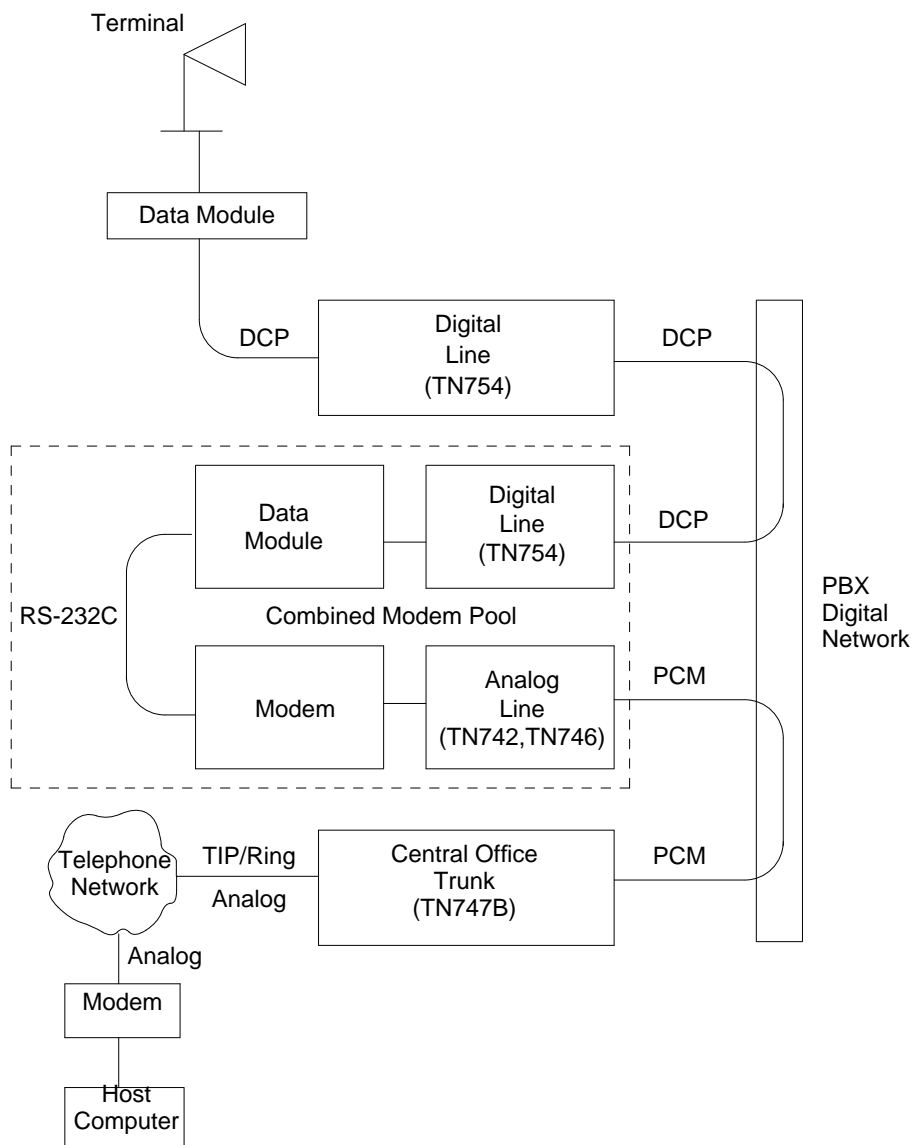
Figure 10-67. Typical Modem Pool Switched Connection with Combined Modem Pool

The Combined Modem Pool conversion resource is the second type available. The function served by the Combined Modem Pool is similar to that of the integrated Pooled Modem circuit pack, but the physical implementation is much different. It has the advantage of supporting any speed the external modem can support. The integrated Pooled Modem circuit pack can only support 300 or 1200 baud transmission rates. The Combined Modem Pool conversion resource consists of a port on a TN742 or TN746 Analog Line circuit pack, an external modem, a Data Module, and a port on a TN754 Digital Line circuit pack. The tip and ring interface of the Analog Line is connected to the modem, the EIA 232C interface of the modem connects to the Data Module, and the DCP interface on the Data Module is connected to the Digital Line port.

The analog modem signals pass through the Analog Line port to the modem. The modem converts these to EIA 232C signals which are passed on to the Data Module. The Data Module further converts the signals to the DCP protocol for the Digital Line port which passes the signals on to the PBX network. See [Figure 10-67](#).

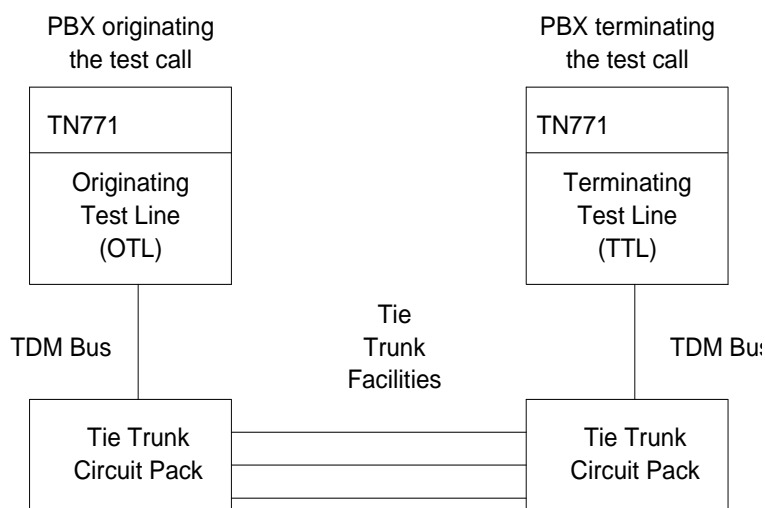
Figure 10-71. ATMS Tie Trunk Test Call

The Maintenance/Test Analog Port is port number 1 on the TN771 Maintenance/Test circuit pack. This port is used by the Automatic Transmission Measurement System (ATMS) as an Originating Test Line (OTL) or Terminating Test Line (TTL) for test calls over analog trunks. [Figure 10-71](#) shows a typical ATMS configuration.

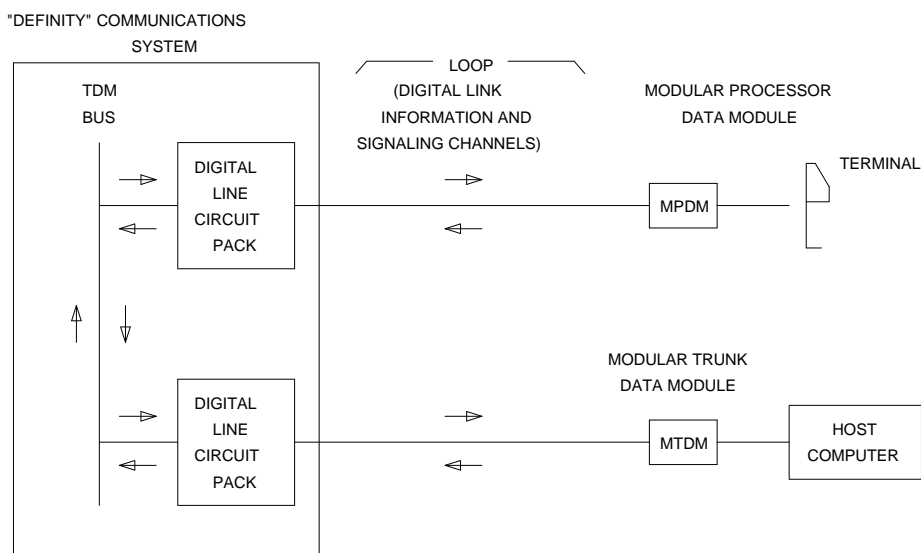
Figure 10-74. Typical Data Module Application

The MPDM provides an interface for Data Terminal Equipment (terminals), and the MTDM (see Note) provides an interface for Data Communications Equipment (transmission equipment such as modems).

As illustrated in [Figure 10-74](#), data modules provide an interface between the system TN754, TN784, TN413 [G3iV2-386], or TN754 [G3iV2-386] Digital Line circuit pack and data equipment such as terminals, host computers, and modems. Data modules are used for both dial-up and permanent circuit-switched data calls. DA data modules provide this interface when the system uses a TN2136 [G3iV2-386] Digital Line circuit pack.

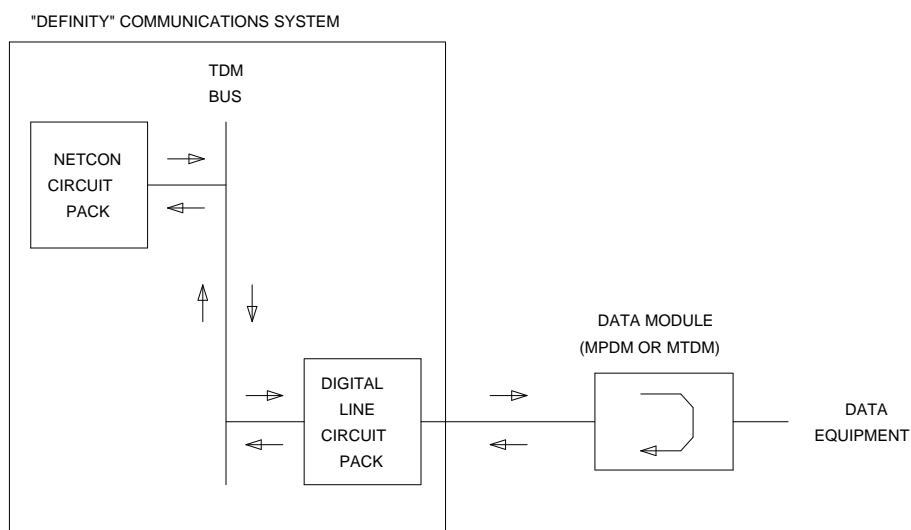
Figure 10-75. Internal Loop Around Test

A signaling message is sent through the digital port circuit pack to the data module under test to request it to enter loop around mode. A test pattern is then sent from the SPE through the Network Control circuit pack (Netcon), over the TDM Bus, through the digital port circuit pack, to the data module where the message is looped around, and sent back through the digital port circuit pack, the TDM Bus, the Network Control circuit pack, and to the SPE where it is checked for consistency.

This test verifies that a data message can be sent from the PBX, through the building wiring, through an internal looparound path in the data module under test, and back to the PBX. [Figure 10-75](#) shows the hardware configuration used for this test.

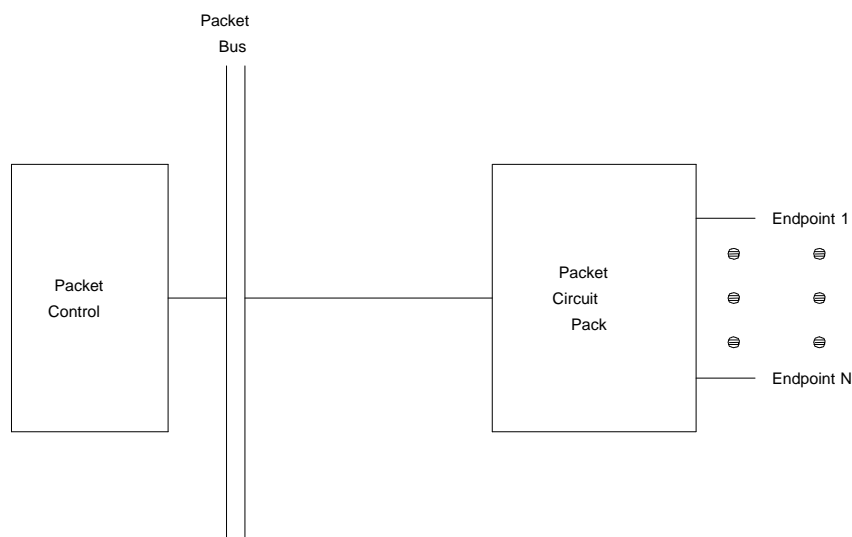
Figure 10-79. Hardware Configuration

The TN778 Packet Control circuit pack is the hardware component that serves as the interface between the SPE and the Packet Bus. It terminates the Link Access Procedure D (LAPD) protocol and provides support for thousands of signaling links. As shown in [Figure 10-79](#), a Packet Control link generally terminates on the Packet Control circuit pack and a packet endpoint which is connected to a Packet circuit pack. An ASAI adjunct is an example of a packet endpoint, and a TN556 is an example of a Packet circuit pack. In G3iV1.1-286 or G3iV2-386, the following Packet circuit packs (packs that can connect to the Packet Bus) are available:

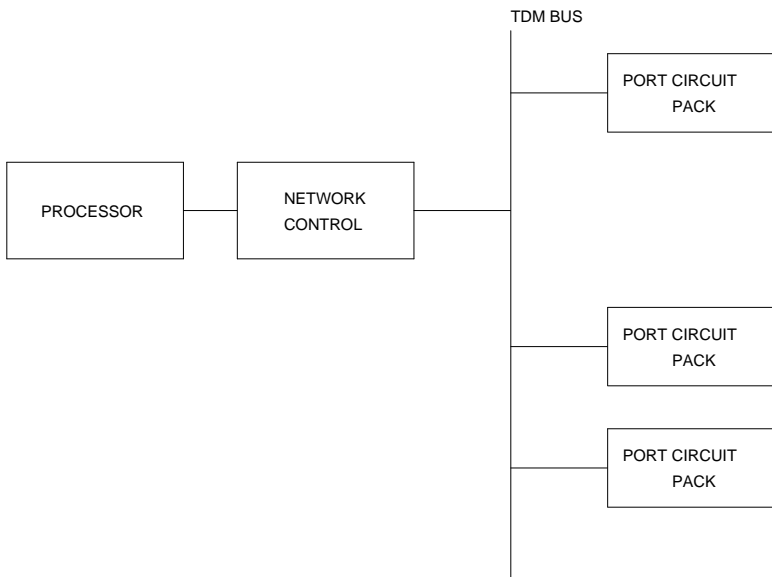
Figure 10-86. Switch Control Connectivity

The Switch Control is used to send control information between port circuit packs and the processor (see [Figure 10-86](#)). This control information is sent via the PPN cabinet's Time Division Multiplex (TDM) Bus. The portion of the TDM Bus used to transmit control messages is called the control channel. The control channel can be on either TDM Bus A or TDM Bus B, but only one bus is used for the control channel at any given time.

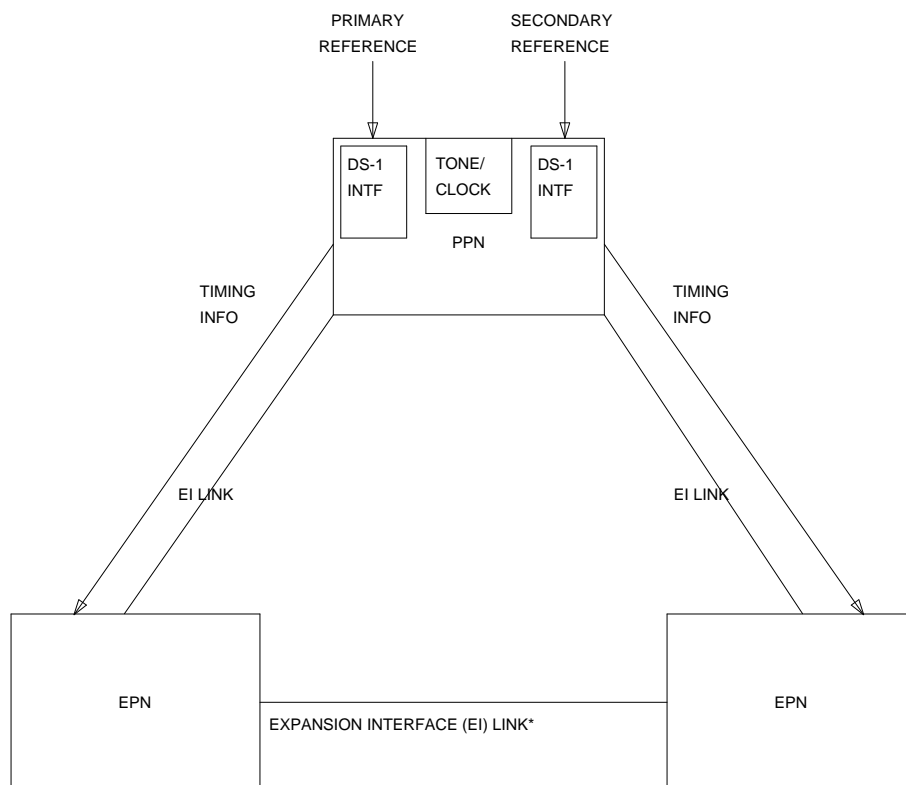
* EPN-TO-EPN LINKS ARE NOT USED TO CARRY TIMING

Figure 10-87. Typical Stratum 4 Synchronization Configuration

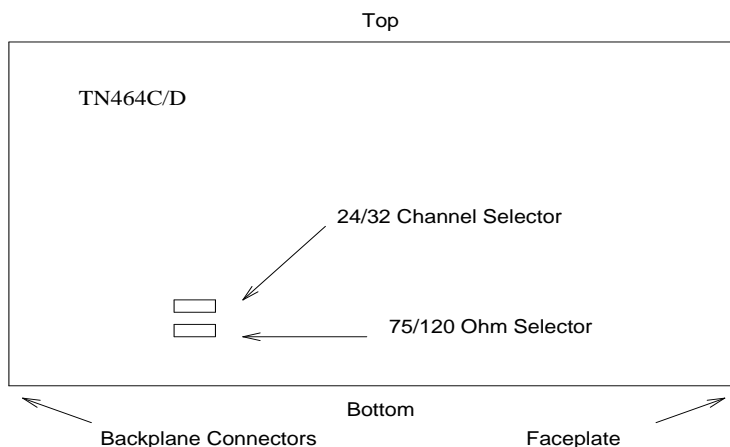
Figure 10-95. TN464C/D DS1 Option Jumpers

[Figure 10-95](#) through [Figure 10-97](#) show how to configure the circuit pack for 24-channel or 32-channel DS1. The channel selection must match the parameters administered on the corresponding DS1 Circuit Pack Form. (US applications use 24 Channels.)

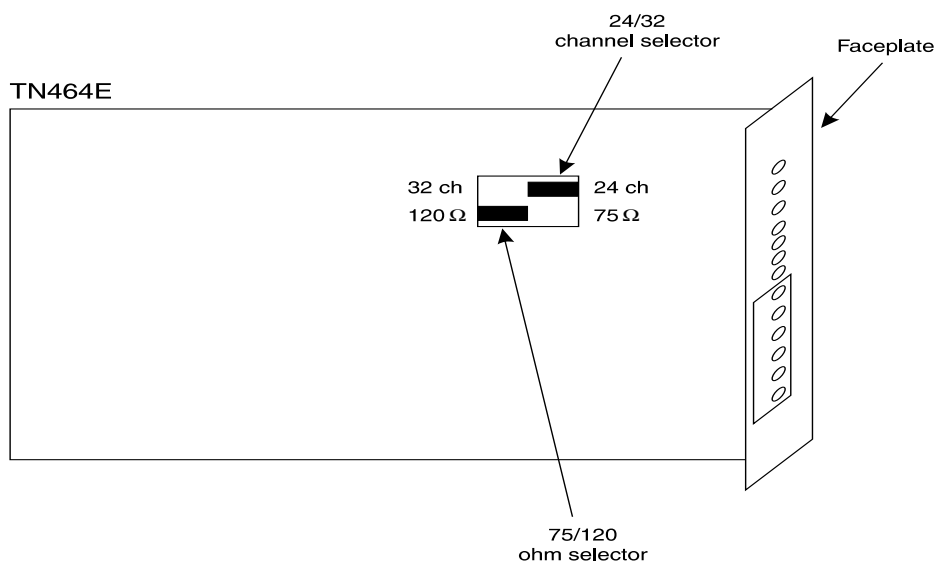
Figure 10-97. TN464E/F DS1 Option switches

The option switch located on the component side of the TN464E/F circuit pack must be set correctly. [Figure 10-97](#) shows how to configure the circuit pack for 24-channel or 32-channel DS1. The channel selection must match the parameters administered on the corresponding DS1 Circuit Pack Form. (US applications use 24 Channels.)
